Front End Digitizer (FREND)

**Advanced Sensors and Instrumentation (ASI)
Annual Program Webinar**

Callie Goetz, PhD

Oak Ridge National Laboratory

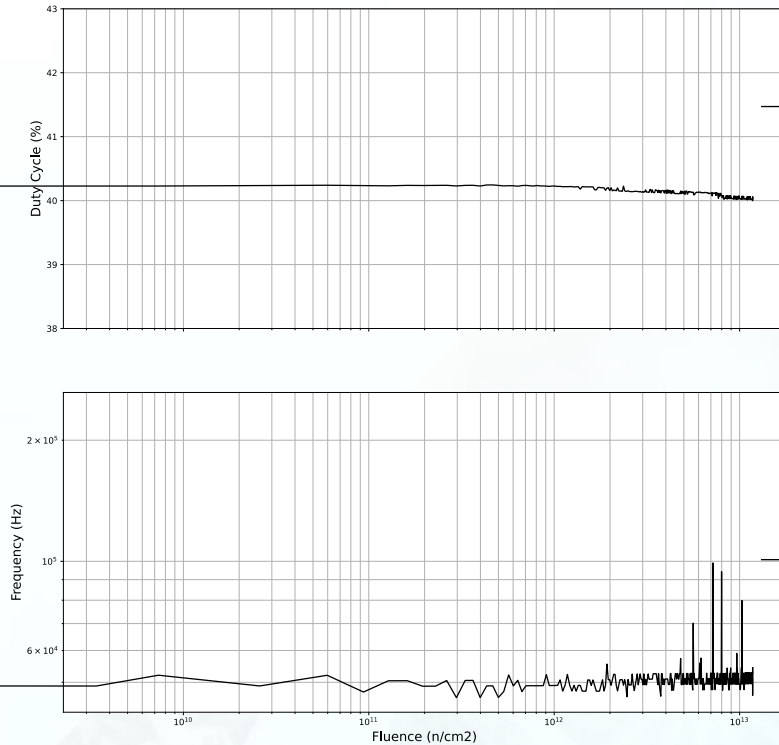
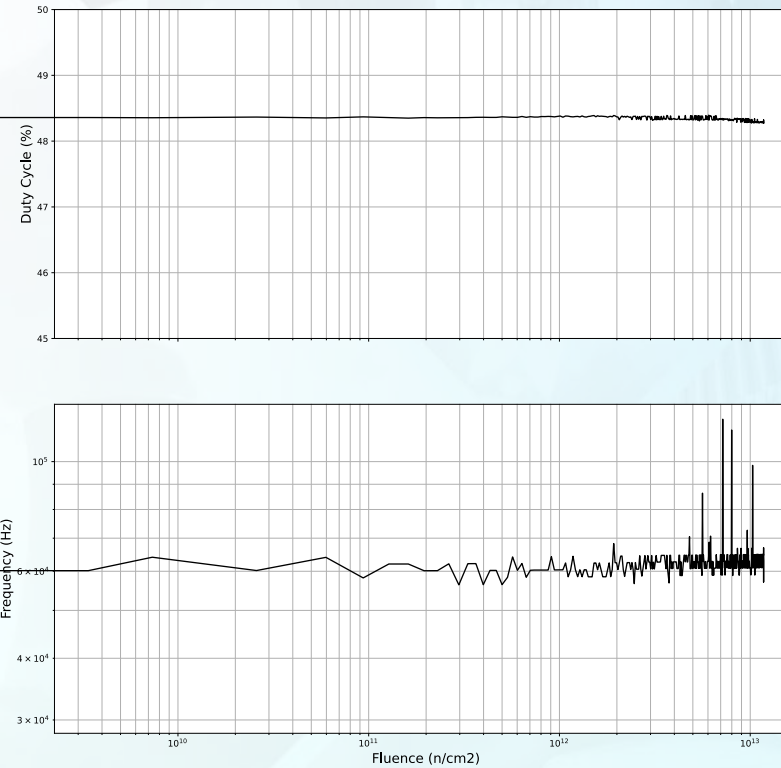
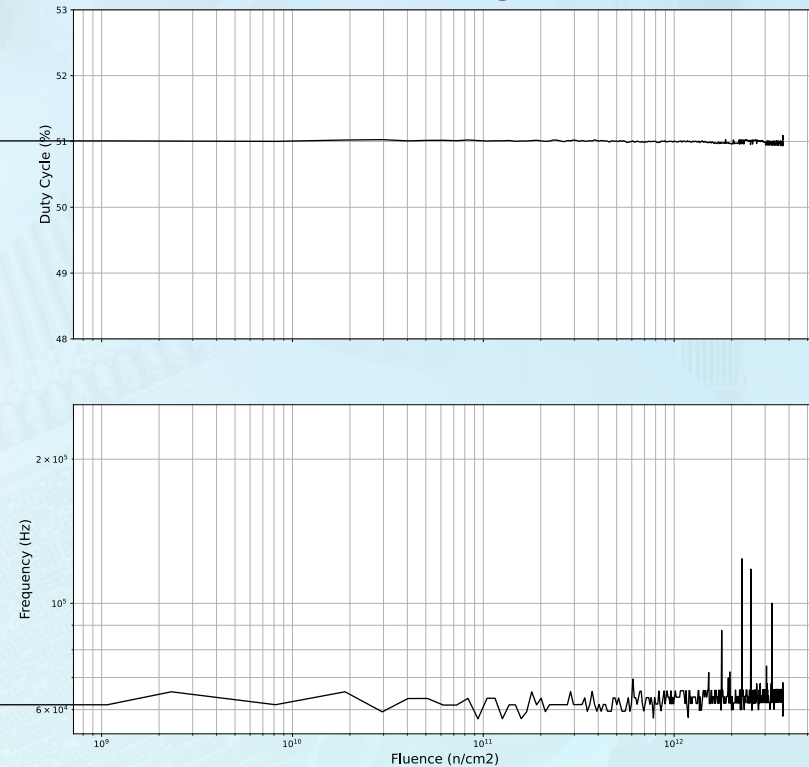
Cf252 Irradiation Results – Clock

- Duty cycle and frequency versus fluence
- Fluence: 10¹³ n/cm²
- No failures observed
- Minimal changes to duty cycle (< 0.1 %)

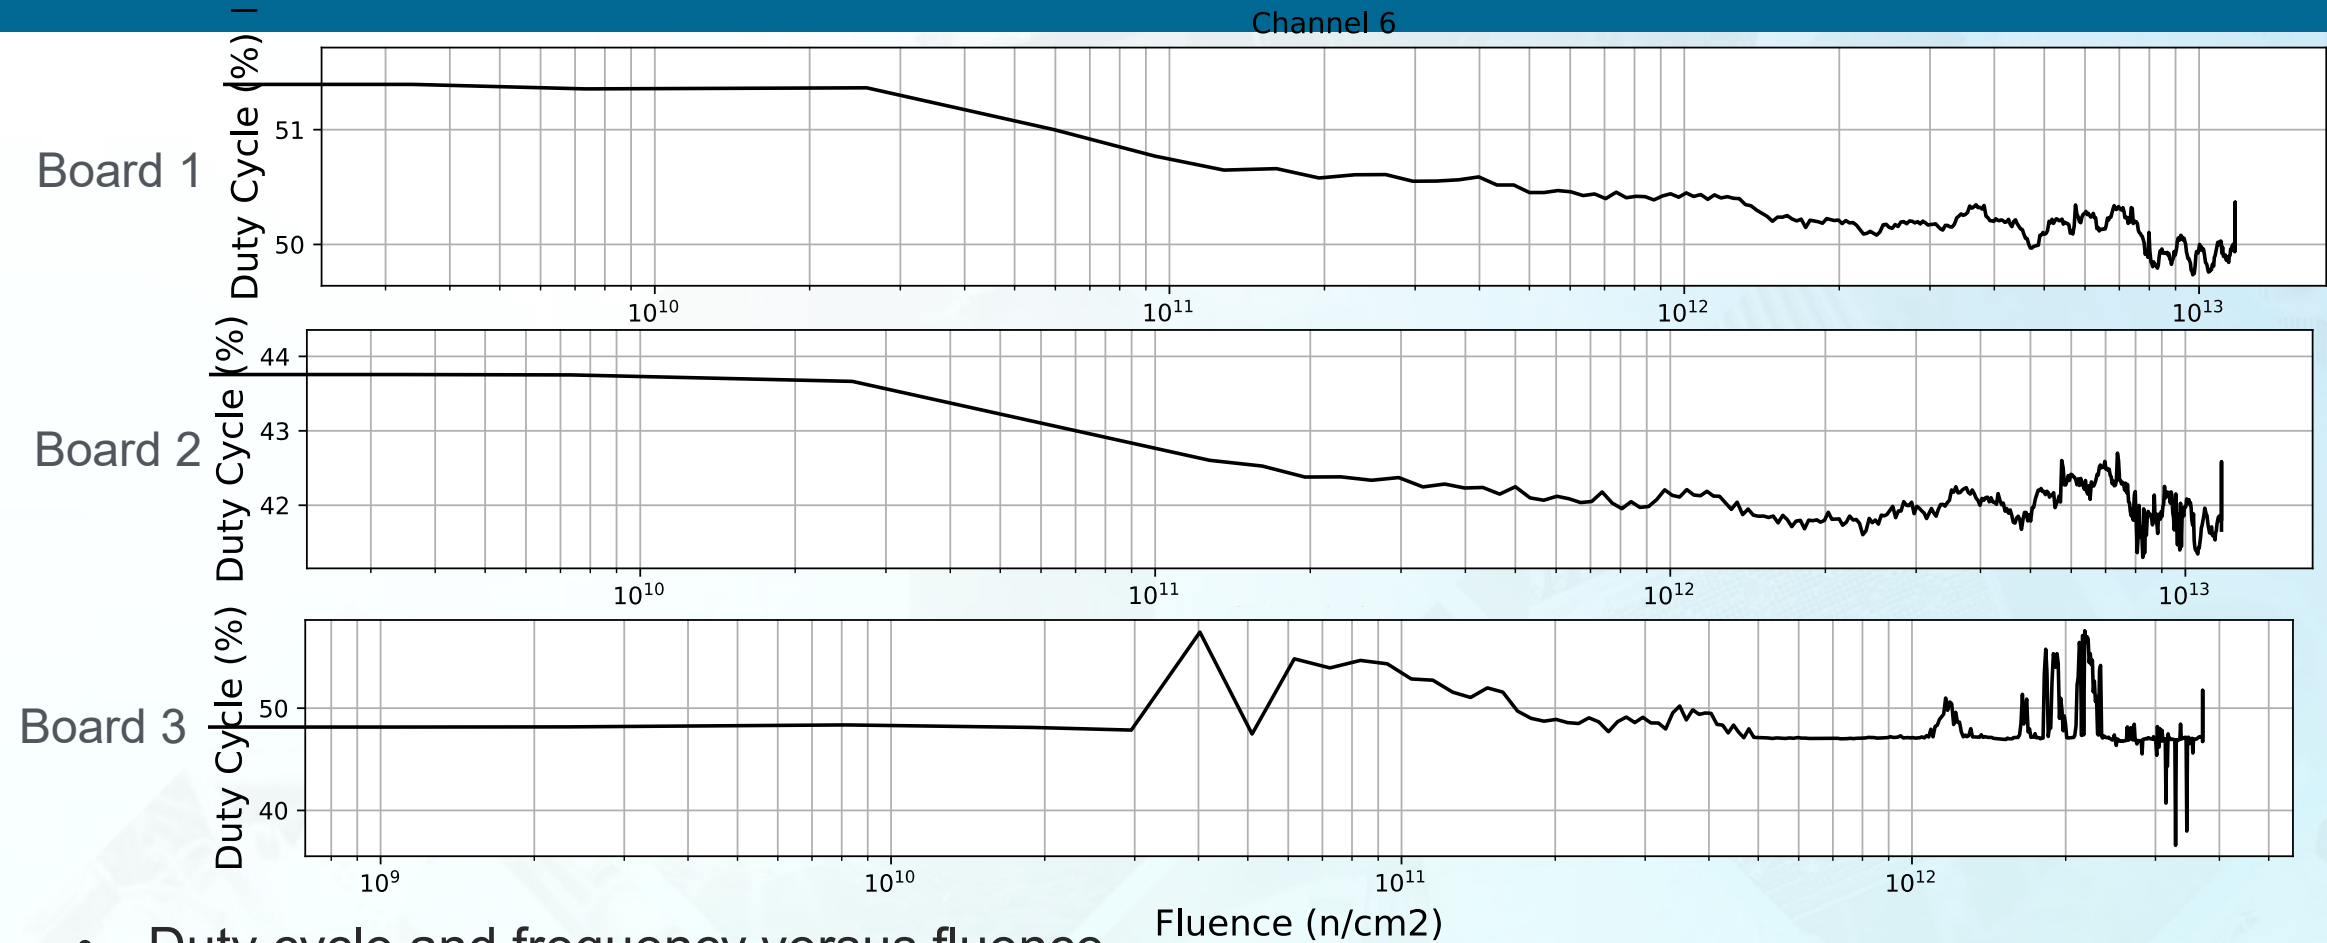
Cf252 Irradiation Results – FREND Output

- Duty cycle and frequency versus fluence
- Fluence: 10^{13} n/cm²
- No failures observed
- Minimal changes to duty cycle (~1%)

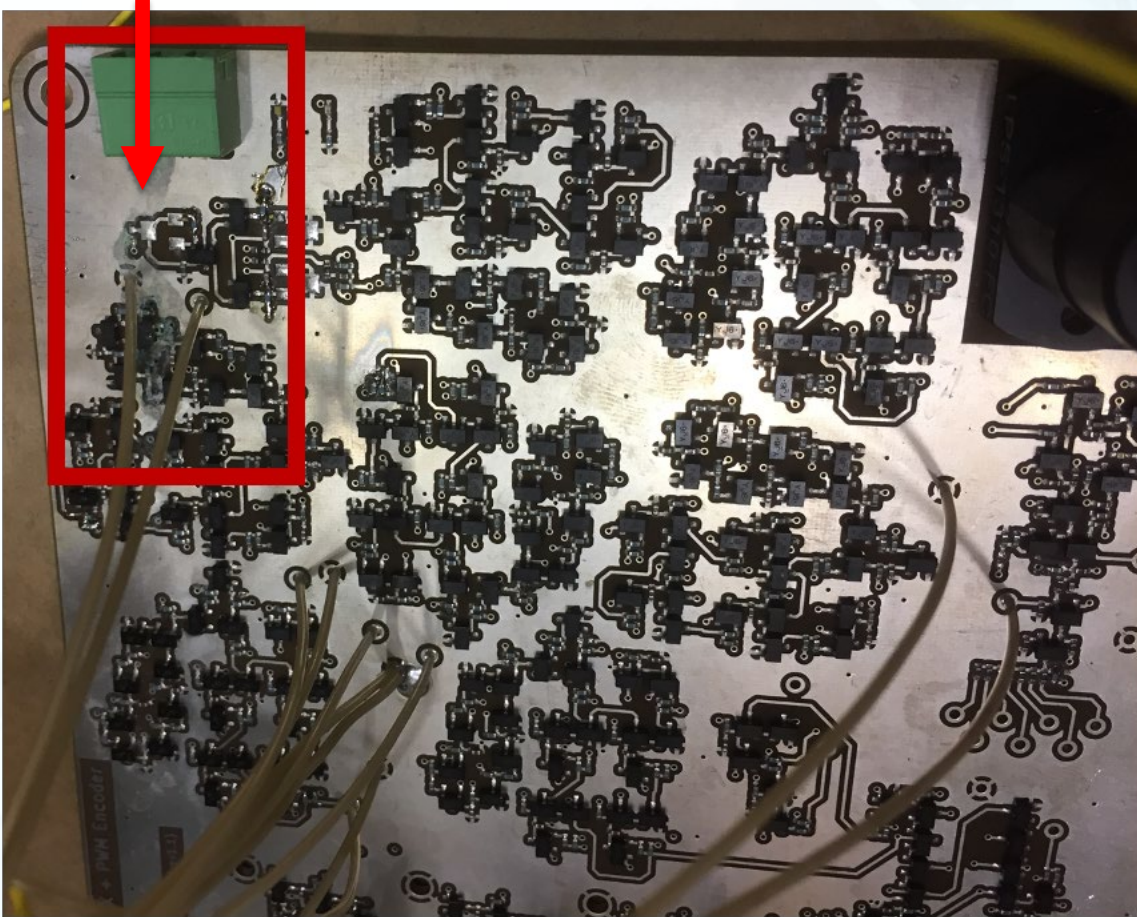
Board 5

Water Damage

Board number	Irradiation facility	Cause of death	Max fluence (n/cm ²)	Death fluence (n/cm ²)
1	²⁵² Cf	NA	2.5×10^{13}	Survived
2	²⁵² Cf	NA	2.5×10^{13}	Survived
3	²⁵² Cf	NA	2.5×10^{13}	Survived
5	PULSTAR	Water damage	1.3×10^{13}	Survived
6	PULSTAR	Water damage	1.3×10^{13}	Survived
8	PULSTAR	Radiation	1×10^{16}	2×10^{14}
9	PULSTAR	Radiation	1×10^{16}	1.8×10^{14}

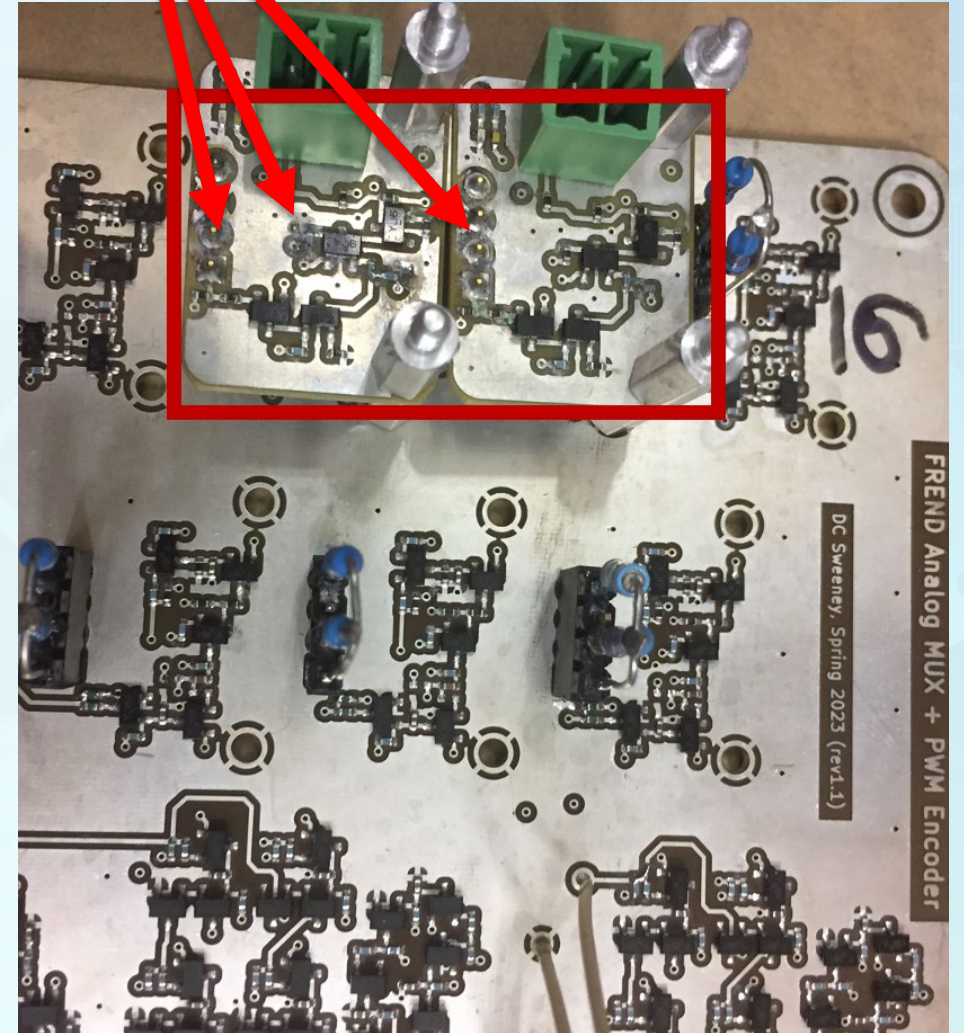
Board 6

Water Damage

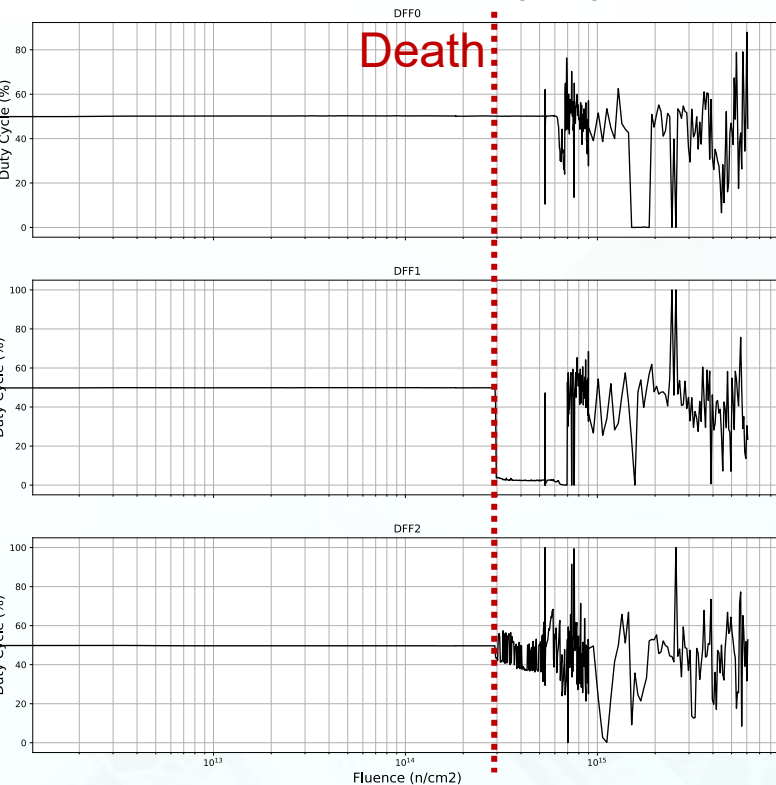
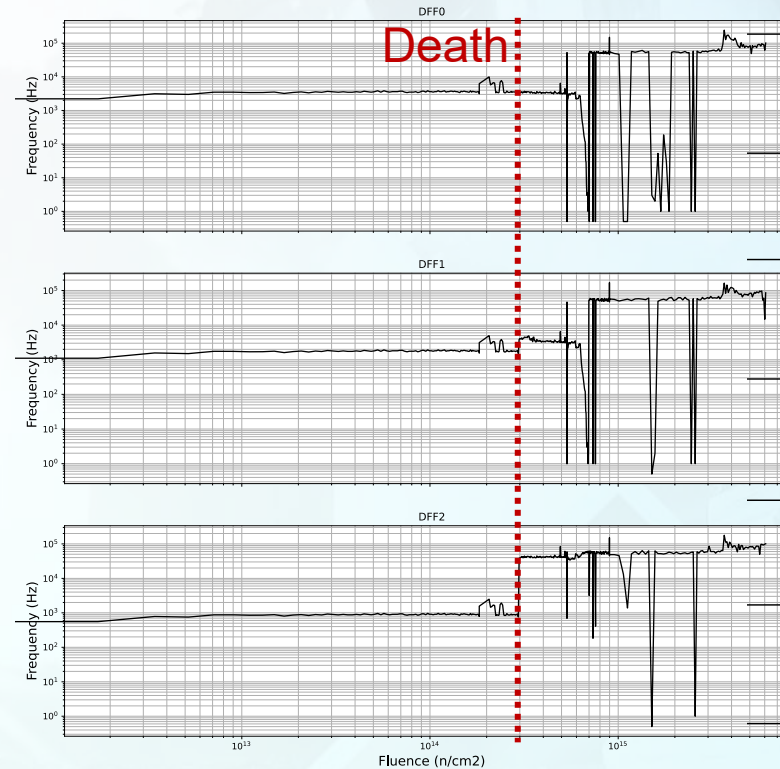
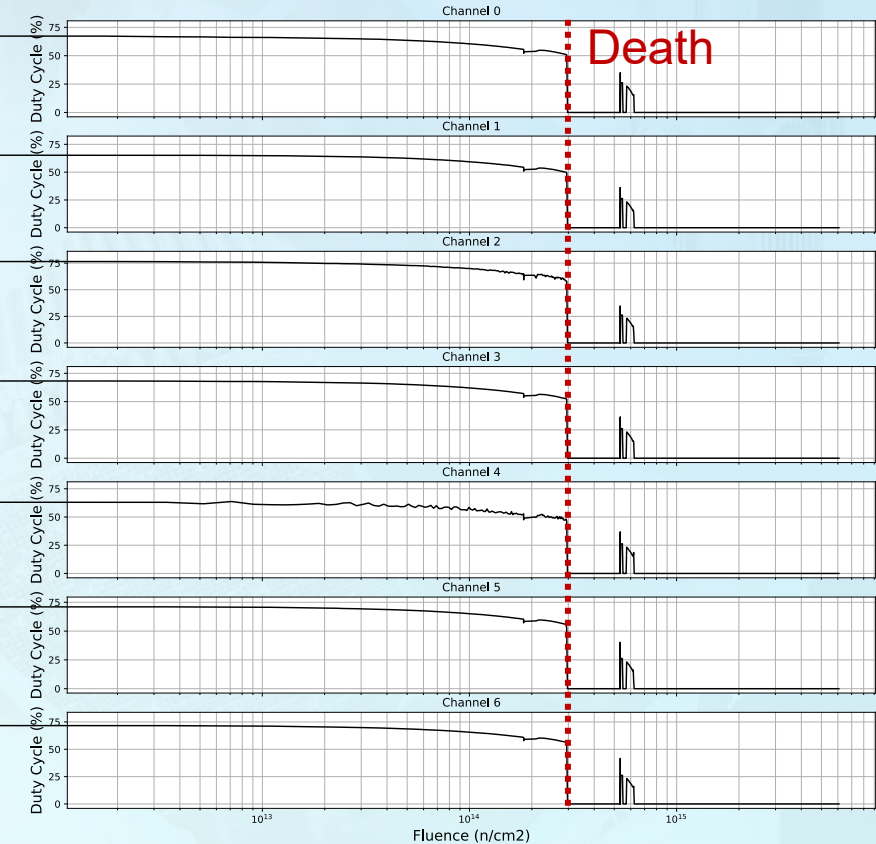
PULSTAR Irradiation Results – Board 8

- Failure on DFF1 at 2×10^{14} n/cm², causing cascading failure
- Frequency change, suggests change to transistor characteristics (threshold voltage) not complete failure

- Results suggest similar neutron-sensitivity in JFETs to CMOS
- Wide bandgap transistors – GaN, SiC
- Increase rail voltages, asymmetric logic towards direction of drift in threshold voltage and drain currents
- **Incorporate design into rad-hard wide-bandgap ASIC**
 - Smaller, allow for on chip redundancy
 - More stable

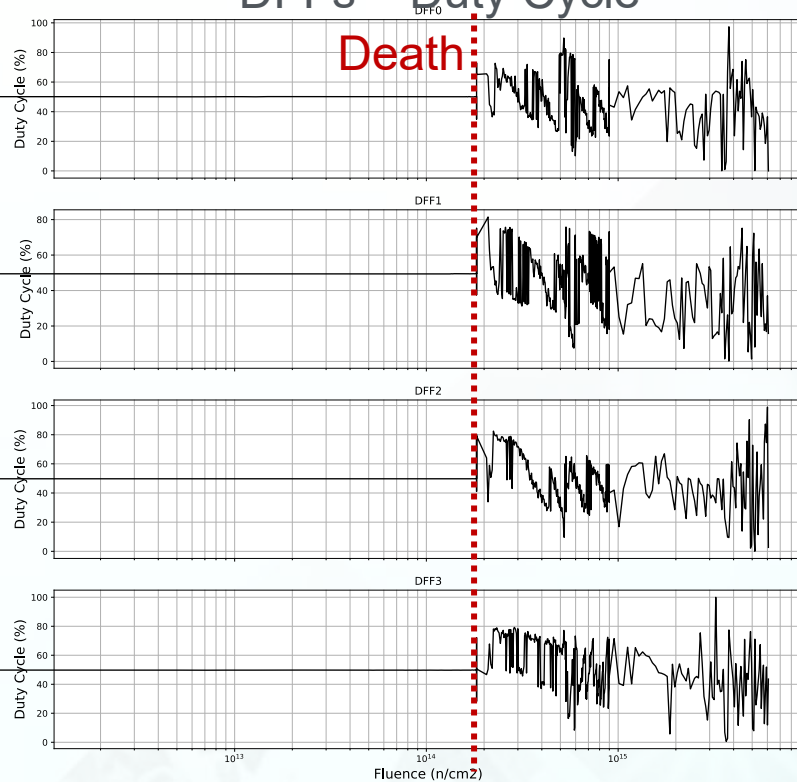
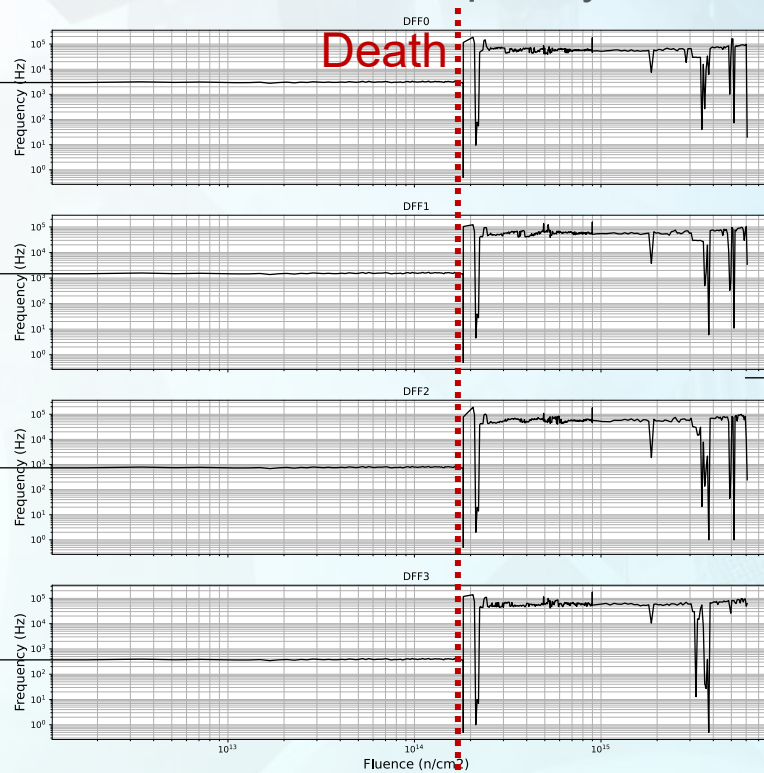
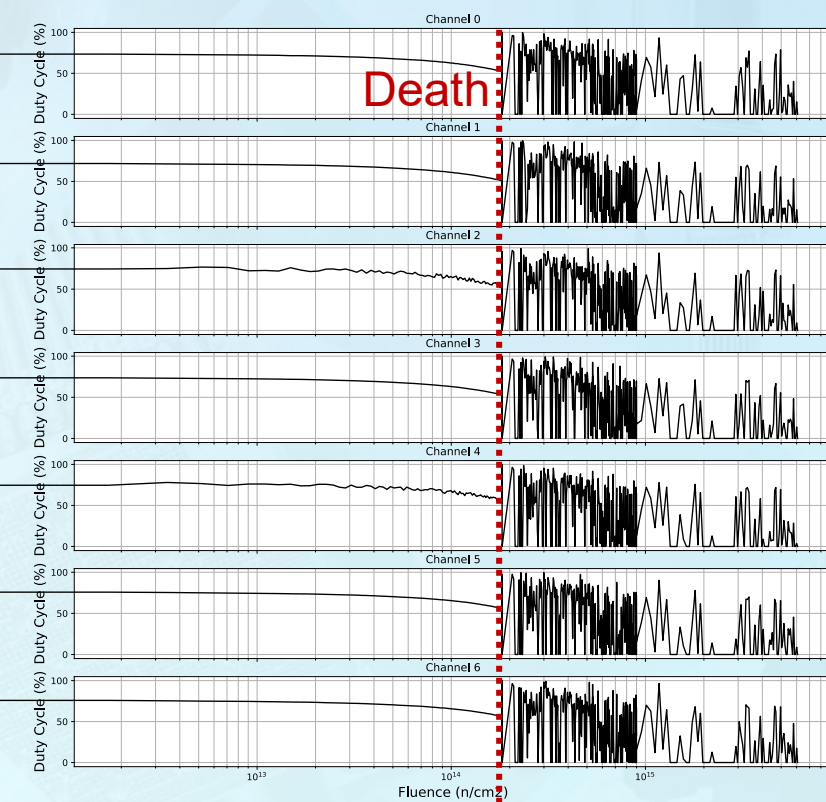
PULSTAR Irradiation Results – Board 9

- Power instabilities observed at 1.8×10^{14} n/cm² (wild input current variations)
- DFF0 became asymmetric, frequency jumps, suggests failure ahead of DFF0, likely divider after clock
- Reactor turned off, standpipe backed away

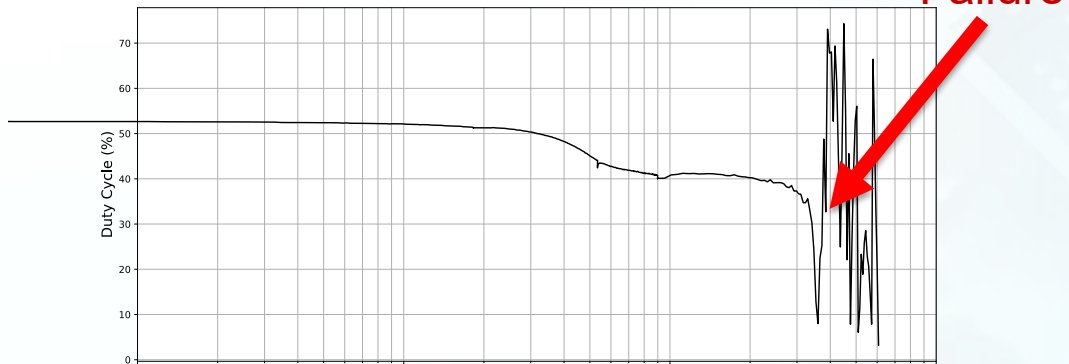
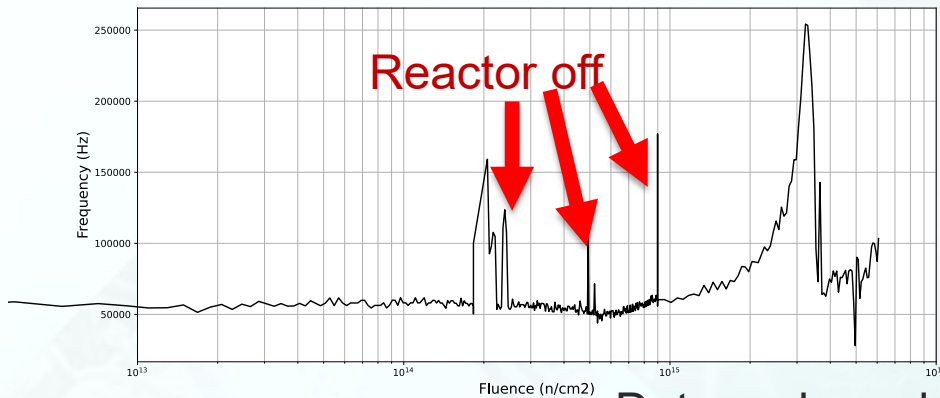
- Duty cycle and frequency versus fluence
- Clocks most radiation-hard portion of circuit
- Board 8 failed at 2.5×10^{15} n/cm²
- Board 9 failed between 7×10^{15} – 1×10^{16} n/cm²
- Offer lessons for radiation-hardness of FRENDR

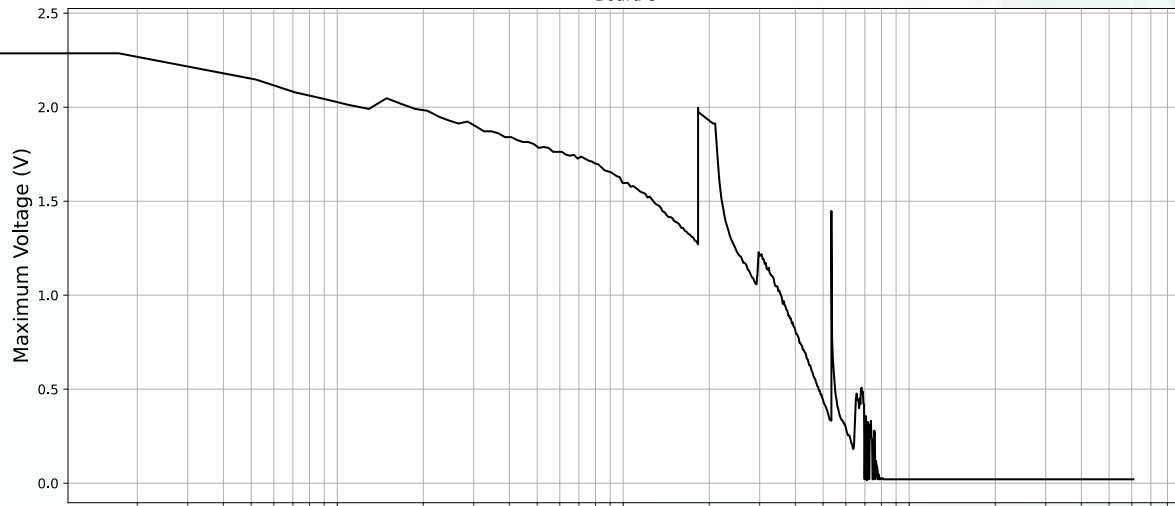
Board 8

- Maximum voltage of laser diode versus fluence – indicative of health
- Exponential decline of signals suggests drift in sawtooth wave or comparator due to irradiation
- Board 9: locks due to failure in synchronization stage, pulled low
